# Characteristics of Deep-seated Landslide and Debris-flow Prevention Function of Cedar Forest

## Learnings from Hirose Landslide, Ishikawa Prefecture, Japan

Prakash S. Thapa<sup>1</sup>, Kazeto Hanzawa<sup>2</sup>, Naoya Katsumi<sup>3</sup>,  
Toshihiko Momose<sup>3</sup>, Seiji Yanai<sup>4</sup>

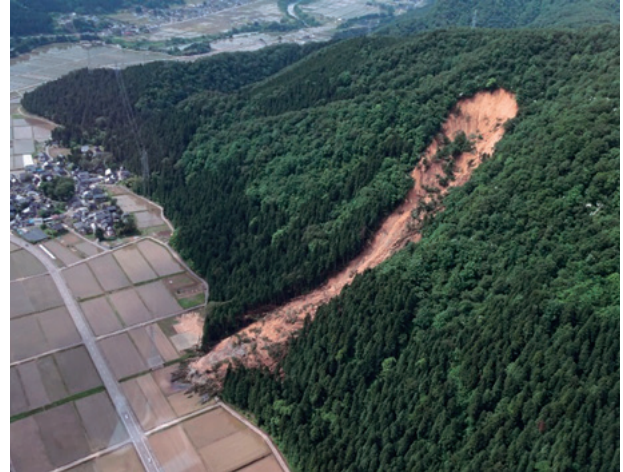
Figure 2: Panoramic view of the collapsed area taken from helicopter

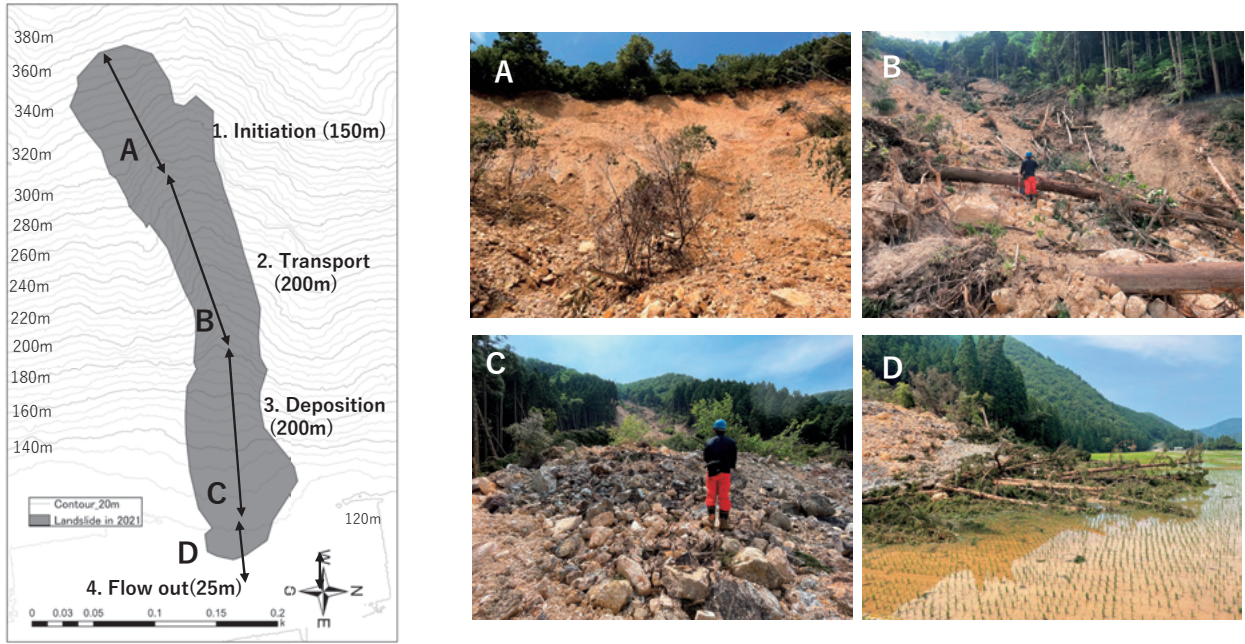
Figure 3: Landslide morphology and its classification: landslide topography with contours (20m) and sediment run-off distance (left); A) debris production (Initiation); B) middle section with toppled trees and driftwood (Transport); C) depositional area with debris (Deposition); D) toe of landslide near paddy fields (Flow out)

Figure 3 shows a plain view of the collapse that occurred in the Hirose area and the situation in each section from debris production (initiation) area to the toe (flow out) area (3A, B, C, D). The total length of the landslide terrain reached 575 m. The initiation area was 78 m wide and 150 m long between 280 and 360 m above sea level, with a collapse area of 1.1 ha. The length of the exposed bedrock is about 40m, and the slope is steep with an angle of over 40°. The base of the slope was flat and mortar-shaped, and medium-sized hardwood trees with roots had slid down and accumulated in the center forming a board-like shape (40 m wide and 60 m long) (Figure 3, A).

The lower part of the valley is a steep slope where collapsed sediments move (Transport zone), with an elevation of 180 to 280 m, a width of 50 m, a length of 200 m, and a slope of 35 to 40°. The central part of the valley was cut off like a slough, and highly viscous mud mixed with spring water and clay was flowing down. At the base of the valley, more than a dozen large-diameter Cedar trees (root diameter of 50 cm or more), which had fallen secondarily after the mudslide, were observed (Figure 3B).

In the deposition area, huge gravels reaching 50 cm~2 m in diameter were deposited on an alluvial cone which lies at 120-180 m above sea level. The deposition area was 70 m wide, 200 m long, and with a slope of about 15°. The deposits had a lobed topography and were layered downstream (Figure 3, Photo C). Its terminus bordered a planted Cedar Forest, which was dammed up to a height of 5 m as the mudslide drifted the Cedar Forest at the terminus. Along its edge, many driftwoods were continuously deposited in overlapping rows for a length of 200 meters.

There was a farm road as a separating boundary between the rice field and the forested area. The debris flow completely covered the road, forming a small hill-like terrain and deposit the debris. The debris flow of landslide overhung the paddy field side about 25 m from the end of the road. A few Cedar trees that had been toppled down and reached almost to the road with debris flow.

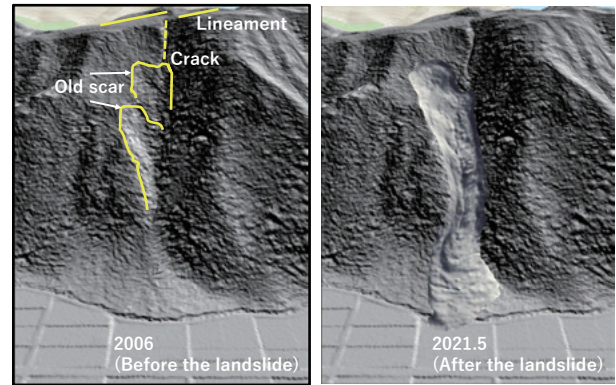
Figure 4: Comparison of geomorphological change before and after the landslide by LiDAR analysis

LiDAR data, taken in 2006, before the collapse were analyzed to reconstruct the pre-collapse topography. Figure 4 shows the shaded relief map created from the topographic survey before 2006 on the left and after 2021 the collapse on the right. The slope around the head scarp where the collapse occurred had a concave catchment topography with steep slope before the collapse. In this zero-order valley, two previously collapsed slope were identified in the middle to upper part of present landslide slope. The first one developed at an elevation of 300 m on the right side of the slope and was 150 m long and 50 m wide. The second is a 50m wide and 100m long collapse zone at an elevation of 340m above the slope.

A clear alluvial cone with a radius of 110 m and an angle of 105° was formed at the bottom of the slope, and its end overhung the alluvial surface (terrace). The debris flow spread and deposited (Flow out zone) from the center of the cone, which was 150 m long and at a narrow angle of 45°.

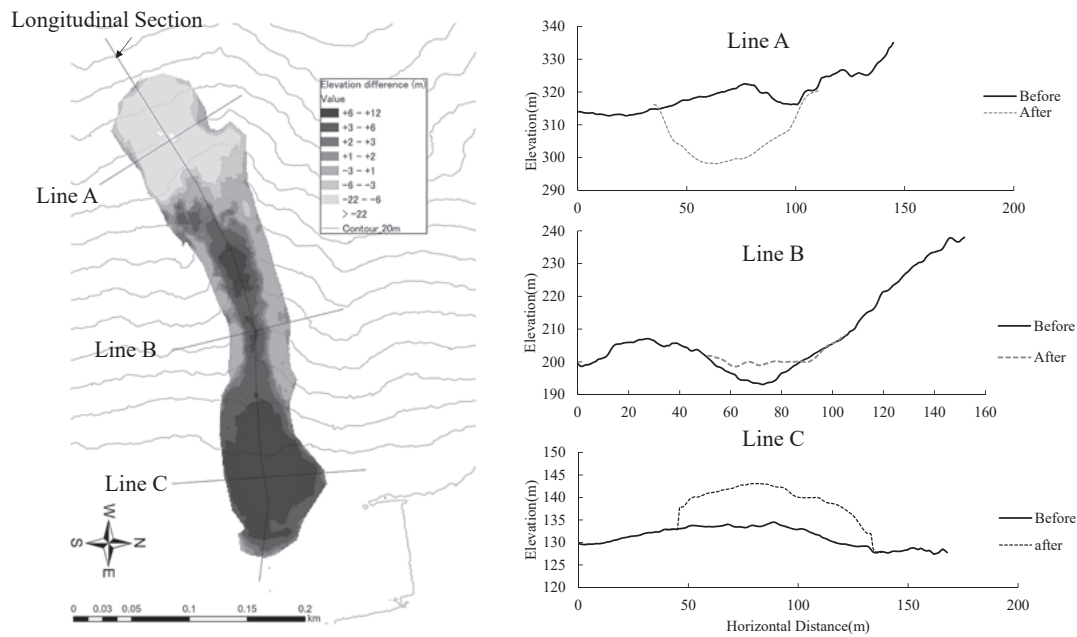
Figure 5 (left) shows a plan view of the difference in elevation before and after the collapse, and the right shows the topographic changes before and after the collapse in the production (initiation) area (Line A), downstream sliding (transport) area (Line B), and deposition area (Line C). In the initiation area, the maximum elevation was depleted by 22 m, and the average elevation was reduced by about 15 m, indicating that arc-shaped slides occurred in the entire area. In the downstream area, the V-shaped valley topography was buried and flattened by about 6m. In the landslide flanks, the slopes were depleted by

Figure 5: Topographic surface changes before and after collapse in three sections: Initiation section-Line A, Transport section-Line B, and deposition area-Line C

about 1 m. In the depositional area, the collapsed soil was deposited in a convex shape with a thickness of about 8 m over an area of about 80 m<sup>2</sup>.

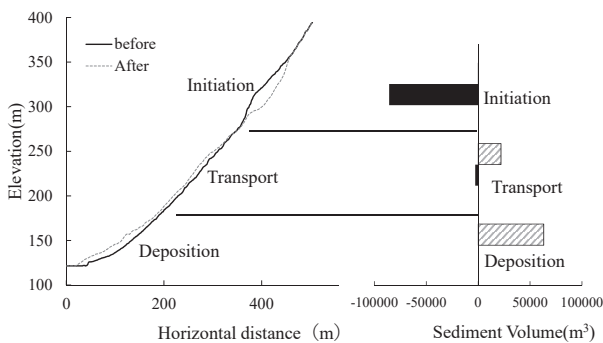
The changes in the longitudinal topography before and after the collapse are shown in Figure 6. The slope before the collapse at an elevation of 300~350m is considered to be an old landslide block, and a concave break point can be recognized. In the present case, the upper slope above the transition line collapsed with a 15m-deep arc-shaped slip surface. In the downstream area from 160m to 300m elevations, sediments cover the slope, and as shown in Figure 5, Line B, the V-shaped valley floor is filled with sediments. Below the elevation of 160 m, the area is a depositional area, and the mudslide that flowed downstream overshot the end of the alluvial cone and advanced further to

the rice paddy field, and stopped. The volume of sediment produced by the landslide in the initiation area was 86,000 m<sup>3</sup>, while 22,000 m<sup>3</sup> was deposited in the transport area, 3000 m<sup>3</sup> was scoured from the valley walls in the transport area, and 63,000 m<sup>3</sup> was deposited in the deposition area. Out of the 89,000 cubic meters of sediment produced, 85,000 cubic meters were transported as debris and 4,000 cubic meters were discharged from the watershed with flowing water.

Figure 6: Longitudinal profile change and sediment production

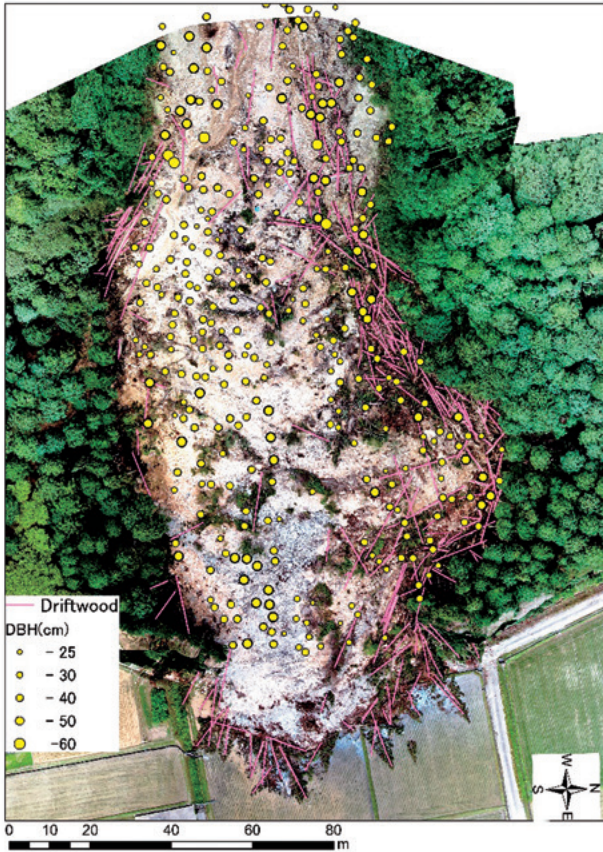
Figure 8: Landslide photo showing driftwood and Cedar trees. Yellow circles indicate the combined location and DBH (cm) of Cedar trees that were destroyed by landslide

Figure 8 shows an orthorectified aerial photograph taken by a Drone over the deposition area. The Cedar Forest in the collapse area has been severely destroyed by the mudslide, and driftwood has accumulated as if swept up around the mudslide. The circles in the Figure 8 indicate the location and size of Cedar trees

that were distributed before the collapse. The main source of the driftwood accumulated on the left bank is the Cedar Forest that was distributed along the flow path (initiation, transport, and deposit). The central part of the landslide area was sparsely forested but occupied with large-diameter sized Cedar trees. These trees were buried by the debris flow, and their tips were slightly exposed on the ground surface. Their arrangement was consistent with the sedimentary structure of the debris flow, and they were distributed in an arc along the lobe-shaped topography (Figure 8). The number of Cedar trees that existed in the initiation, transport, and the deposit area was determined to be 540, out of which 230 trees were deposited as driftwood on the ground surface. The remaining, 310 trees, are estimated to be buried in the debris flow material and not visible.

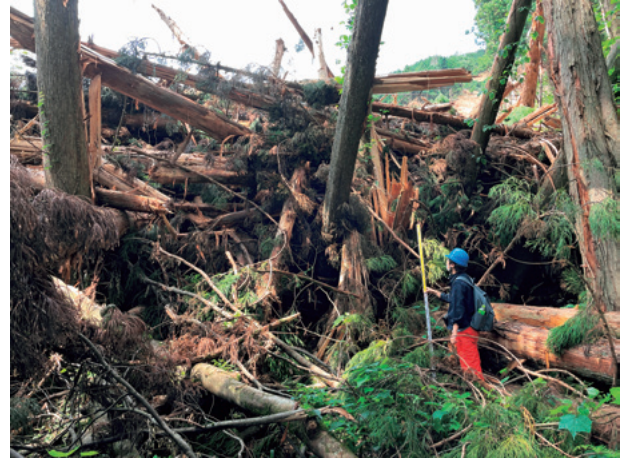
Figure 9: Sediment accumulation by “retention-dam” like structure of driftwood observed in the sedimentation area

Figure 9 shows the accumulation of driftwood at the end of the left bank. The roots of these driftwood has diameter of 84 cm on maximum and 46 cm on average, forming a retention dam-like structure up to 8 m high and storing a large amount of sediment behind it.

On the other hand, another important disaster mitigation function observed this time was that the standing trees captured the driftwood that flowed down like vertical piles and accumulated to serve as a retention-dam-like structure, storing a large amount of collapsed sediment behind them. The width of the dam reached 120 m on the left bank, and its height was up to 8 m. Driftwood spilled by mudslides is a nuisance in terms of disaster prevention, as it can get caught on bridge piers, blocking the flow of the river and causing flooding (Mizuhara, 2016). However, during the 2018 mudslide disaster in Hiroshima Prefecture, it was reported that sediment was deposited up to 1~3 m thick by driftwood dams (Nonoyama et al., 2020), which is much smaller than the Hirose Landslide. The major difference from the Hiroshima Prefecture case is that the Cedar plantation in the Hirose area had large-diameter trees (approximately 48 cm), which were able to withstand

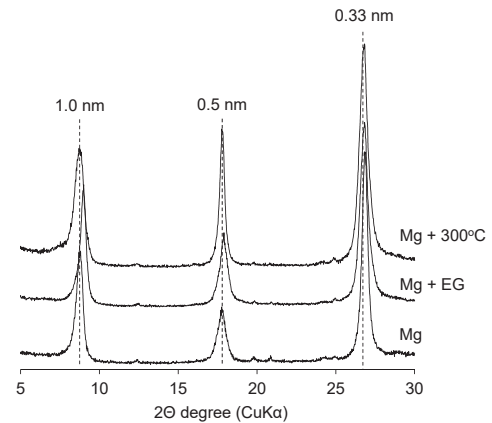
Figure 11: Results of clay mineral analysis of sampled soil

Figure 11 shows the XRD patterns of the clay samples; the lattice plane spacing calculated from the peak positions of the XRD patterns of the Mg-saturated samples were 1.0 nm, 0.5 nm, and 0.33 nm, consistent with those of illite. Furthermore, the peak at 1.0 nm, corresponding to the 001 plane of clay minerals, did not change with EG or heat treatments, which is also consistent with the characteristics of illite (Shiramizu, 2010). In addition, for hydrohalloysite, which, like illite, has a peak near 1.0 nm, (1) the peak shifts from 1.0 nm to 0.7 nm due to dehydration associated with heat treatment, and (2) the peak shifts from 1.0 nm to 1.1 nm due to expansion of the interlayer by EG treatment (Joussein et al., 2005). In summary, the mineral species is very likely illite, since the XRD pattern of this sample is consistent with that of illite, and the above peak shift was not confirmed for the 1.0 nm peak.

Analysis of clay minerals exposed on the collapse surface revealed that illite was the predominant mineral. According to Maeda et al. (2011), geological characteristics of hydrothermal alteration zone landslides occur mostly in the potash feldspar and illite zones. The Kawai Mine, where the ceramic stone used to make Kutani ware is sand bedded, is located 1 km southwest of the Hirose Landslide area, and the surrounding andesite and rhyolite are widely altered. Since the liquid limit of this clay layer is smaller than the saturated water content (i.e., the fluidization index exceeds 1), it is expected to become liquid and easily fluidized as this clay layer approaches its saturated water content due to rising groundwater. It is highly likely that the clay layer that underwent this alteration was used as a slip surface and that a deep collapse occurred. Under these geological conditions, in this area where there are many lineaments and faults, it is possible that similar deep failures may occur in the future.
