# Characteristics of Deep-seated Landslide and Debris-flow Prevention Function of Cedar Forest

## Learnings from Hirose Landslide, Ishikawa Prefecture, Japan

Prakash S. Thapa<sup>1</sup>, Kazeto Hanzawa<sup>2</sup>, Naoya Katsumi<sup>3</sup>,  
Toshihiko Momose<sup>3</sup>, Seiji Yanai<sup>4</sup>

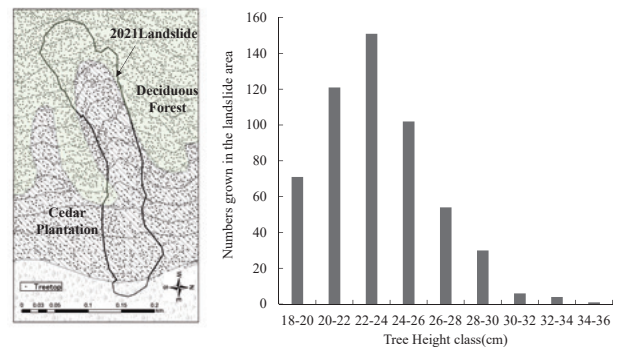
Figure 7: Tree height frequency distribution of planted Cedar Forest before the landslide

Figure 7 shows the number of trees and their height distribution in the collapse area estimated based on the distribution of Cedar plantation forest shoot tips

before the collapse. Most of the upper slope was covered with secondary broadleaf forest. However, most of the middle-downstream and sedimentation areas were covered with Cedar Forest, with average height of 22-24 m, and a few exceeding 30 m. The number of trees and their height frequency distribution are shown in Figure 7. The DBH for all the 540 Cedar trees was estimated and the critical turning moment was calculated. The critical turning moment calculated by equation (1) is 59.3 kNm per tree and overall is 32067 kNm. When this value was recalculated based on the estimated tree height in 2021, 15 years later, it was found that the total turning resistance was 73069 kNm, almost double to the turning resistance of 2006.

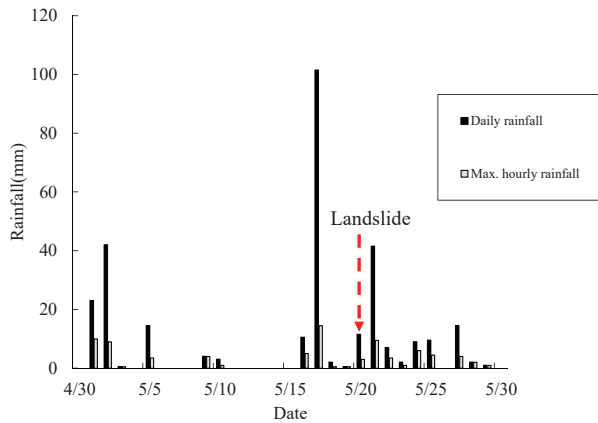
Figure 10: Daily and hourly maximum rainfall before and after the landslide (May 2021). Source: Japan Meteorological Agency (2021)

Figure 10 shows the daily and hourly maximum rainfall before and after the collapse. On May 20, 2021, when the landslide occurred, the rainfall was 11.5 mm and the maximum hourly rainfall was only 3 mm. Prior to this, there was rather heavy rainfall on May 17, with a daily rainfall of 105 mm and an hourly rainfall of 11.5 mm at 8:00 a.m. From then until May 20, there was only a little amount of

rainfall with a maximum daily rainfall of 10 mm. However, in early May, there was rainfall of 15-42 mm per day.
